Manhole Inspection Summary

Manhole # S15SS_005MH

Insp Date: **3/5/09 10:13 AM**

Location Address: **3320 BURLEITH AVE**

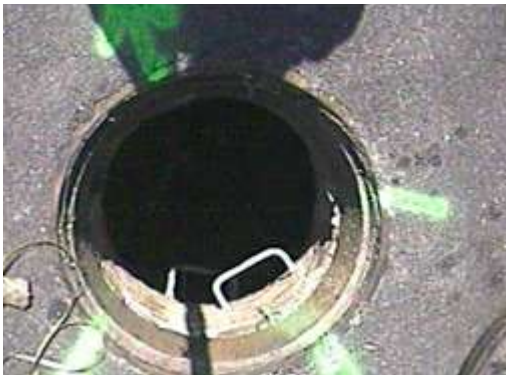
Top View

Offset: **3** (in.)

frame offset

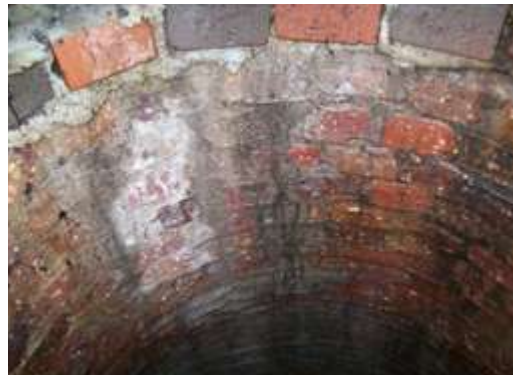
Defect 5

Infiltration: ☒ None ☐ Joint ☐ Cracks ☐ Mortar ☐ Roots ☐ Wall

infiltration evidence

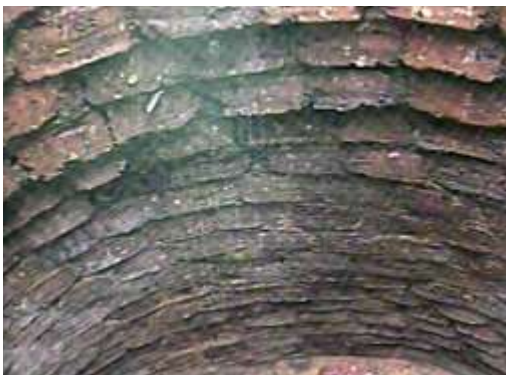
Defect 4

Infiltration: ☐ None ☐ Joint ☐ Cracks ☐ Mortar ☐ Roots ☒ **Wall**

infiltration at barrel

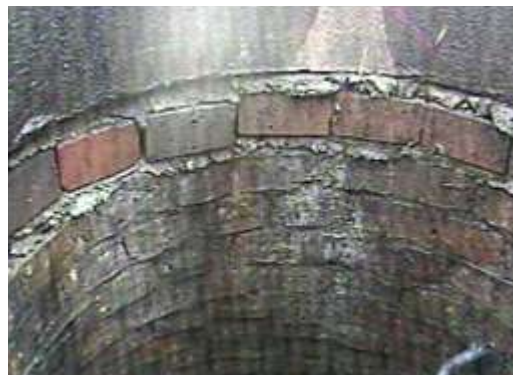
Defect 3

Infiltration: ☐ None ☐ Joint ☐ Cracks ☐ Mortar ☐ Roots ☒ **Wall**

infiltration at corbel

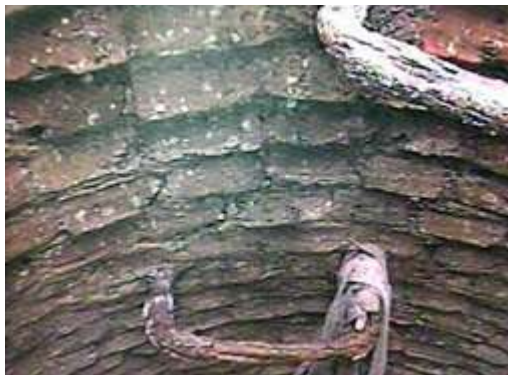
Defect 2

Count: **3** Missing: **0** ☒ **Corroded**

corroded steps

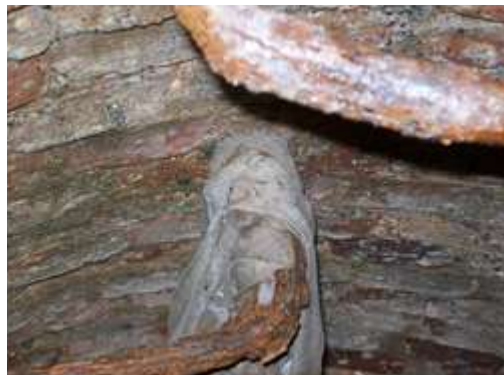
Defect 1

☒ **Evidence Of Surcharge** Depth: **2** (ft.) ☐ Active Surcharge Present

evidence of ASUR

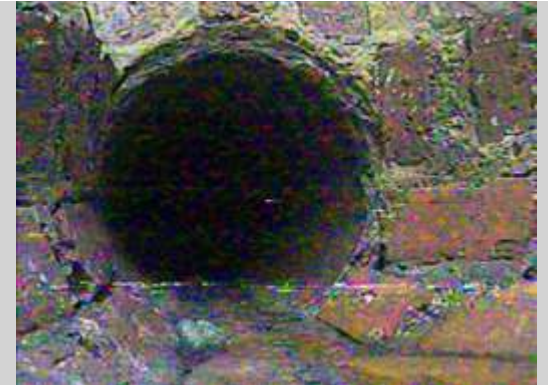
12 O'Clock Outflow

8 in. Circular Gravity Sewer
Pipe Out @ 12 O'Clock

Pipe Height: (in.) Direct
Pipe Material: **Clay** ☐ Pipe Lined
Invert Depth: **7.26** (ft.) Flow Characteristics: **Slow**
Deposits: ☒ None ☐ Mud ☐ Sludge ☐ Debris ☐ Grease
Silt Depth: (in.) Deposits Extent:
Infiltration: **None** Pipe Seal Cond: **Sound**

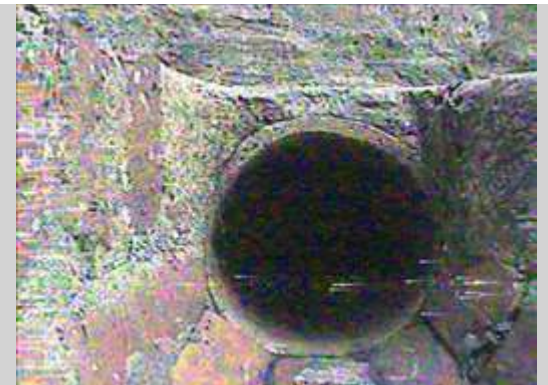
4 O'Clock Inflow

6 in. Circular Gravity Sewer
Pipe In @ 4 O'Clock

Pipe Height: (in.) Direct
Pipe Material: **Clay** ☐ Pipe Lined
Invert Depth: **6.95** (ft.) Flow Characteristics: **None**
Deposits: ☒ None ☐ Mud ☐ Sludge ☐ Debris ☐ Grease
Silt Depth: (in.) Deposits Extent:
Infiltration: **None** Pipe Seal Cond: **Sound**

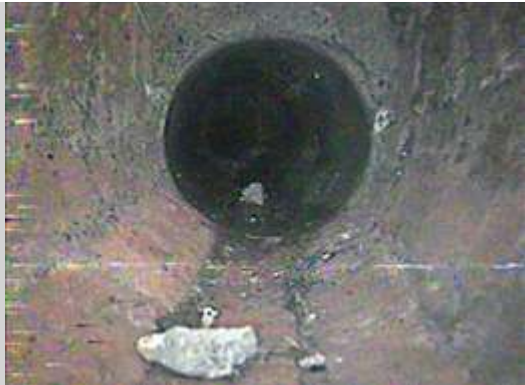
6 O'Clock Inflow

6 in. Circular Gravity Sewer

Pipe In @ 6 O'Clock

Invert Depth: **6.91** (ft.) Flow Characteristics: **None**

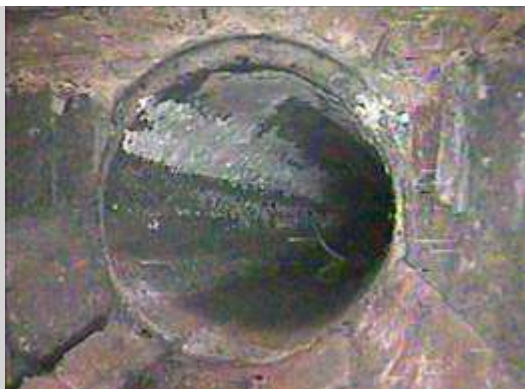
9 O'Clock Inflow

8 in. Circular Gravity Sewer

Pipe In @ 9 O'Clock

Invert Depth: **7.10** (ft.) Flow Characteristics: **Slow**

Silt Depth: (in.) Deposits Extent: **Light**
